DEVELOPMENT OF WELDING TECHNIQUES AND FILLER
METALS FOR HIGH STRENGTH ALUMINUM ALLOYS

Annual Summary Report
Project No. 07-1063

SOUTHWEST RESEARCH INSTITUTE
SAN ANTONIO HOUSTON

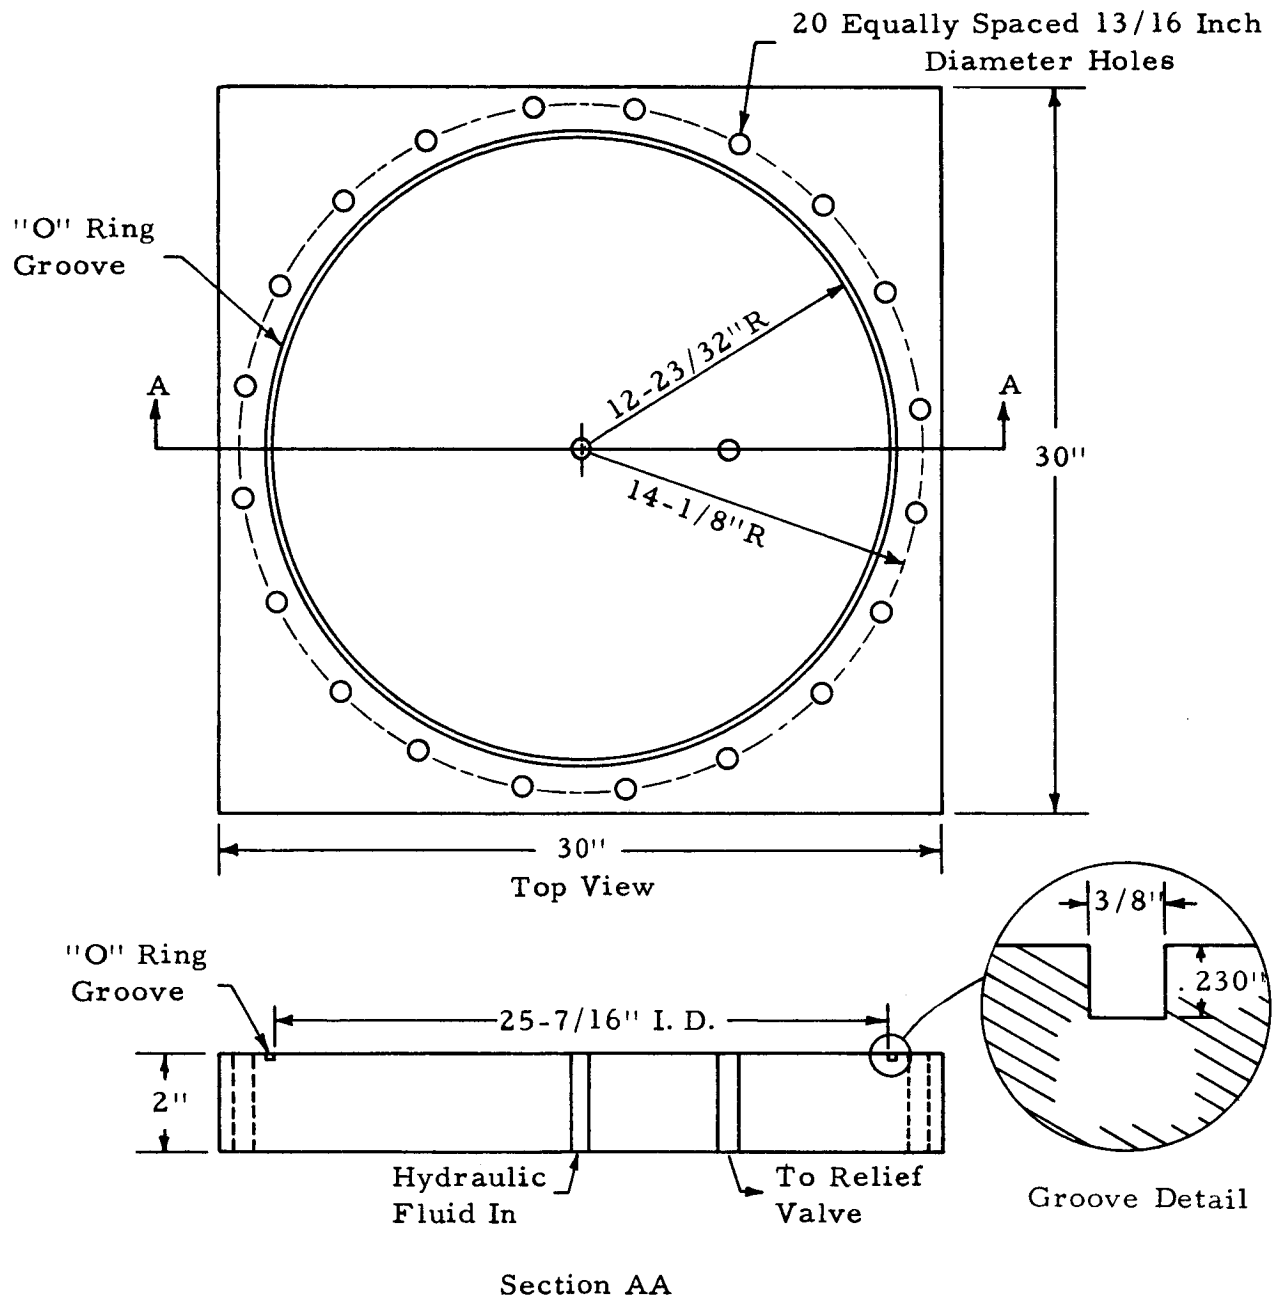
FIGURE 30. BOTTOM DIE OF HYDRAULIC BULGE FIXTURE

An "O" ring seal was provided to prevent leakage of the hydraulic fluid from the die-test panel interface. The groove detail for the "O" ring is also shown in Figure 30. A fitting at the center of the die is used to introduce the hydraulic fluid.

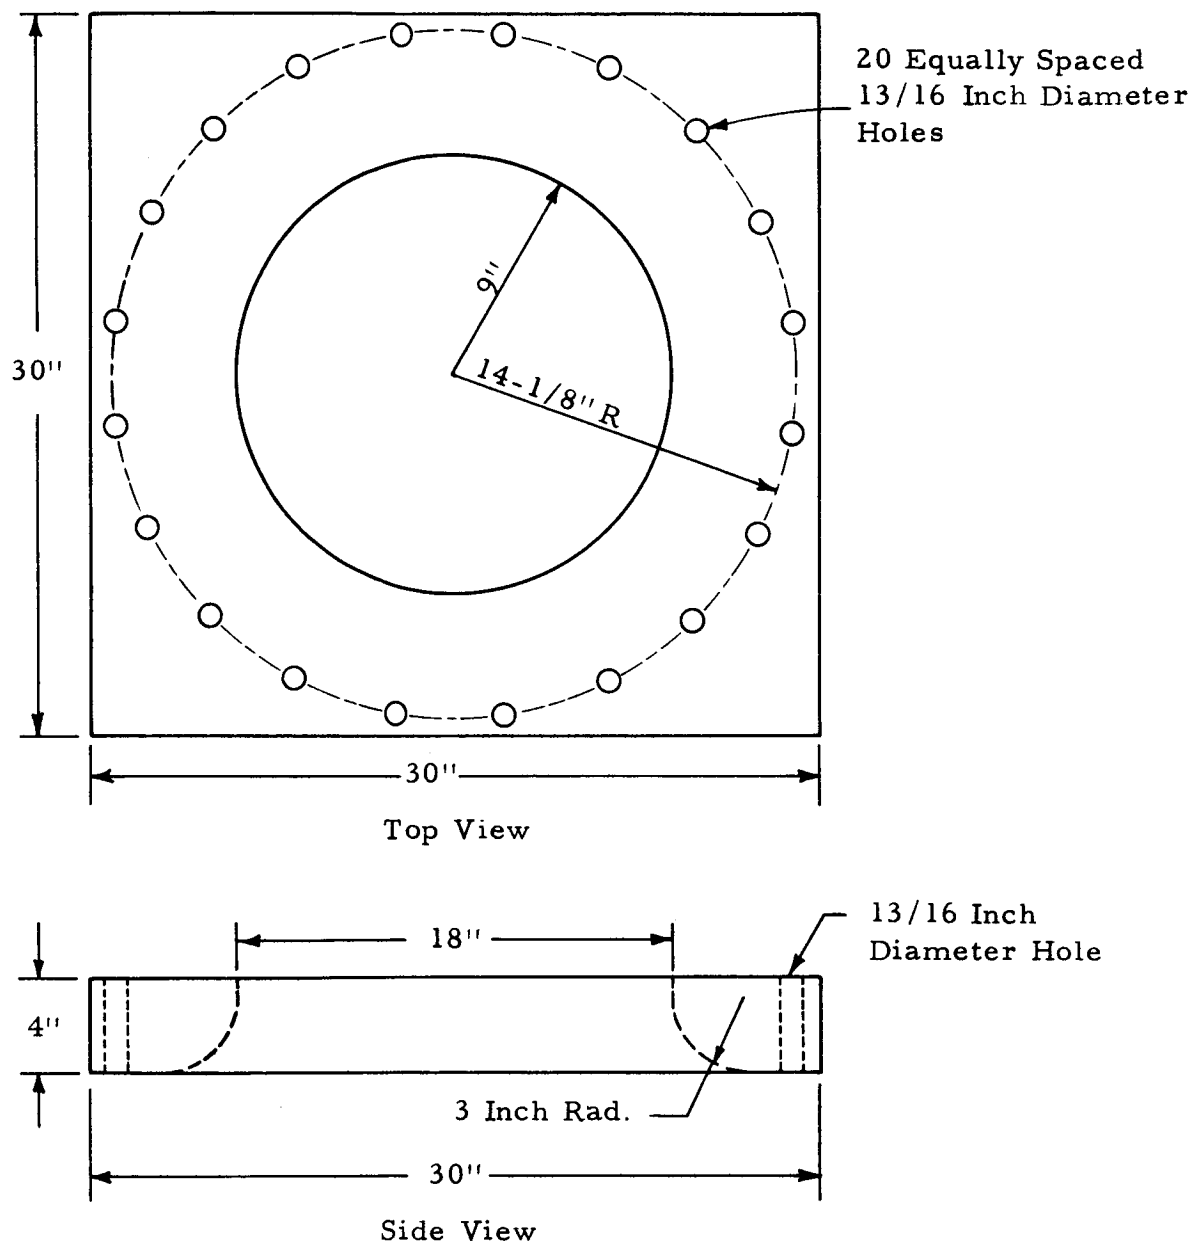
FIGURE 31. TOP DIE OF HYDRAULIC BULGE FIXTURE

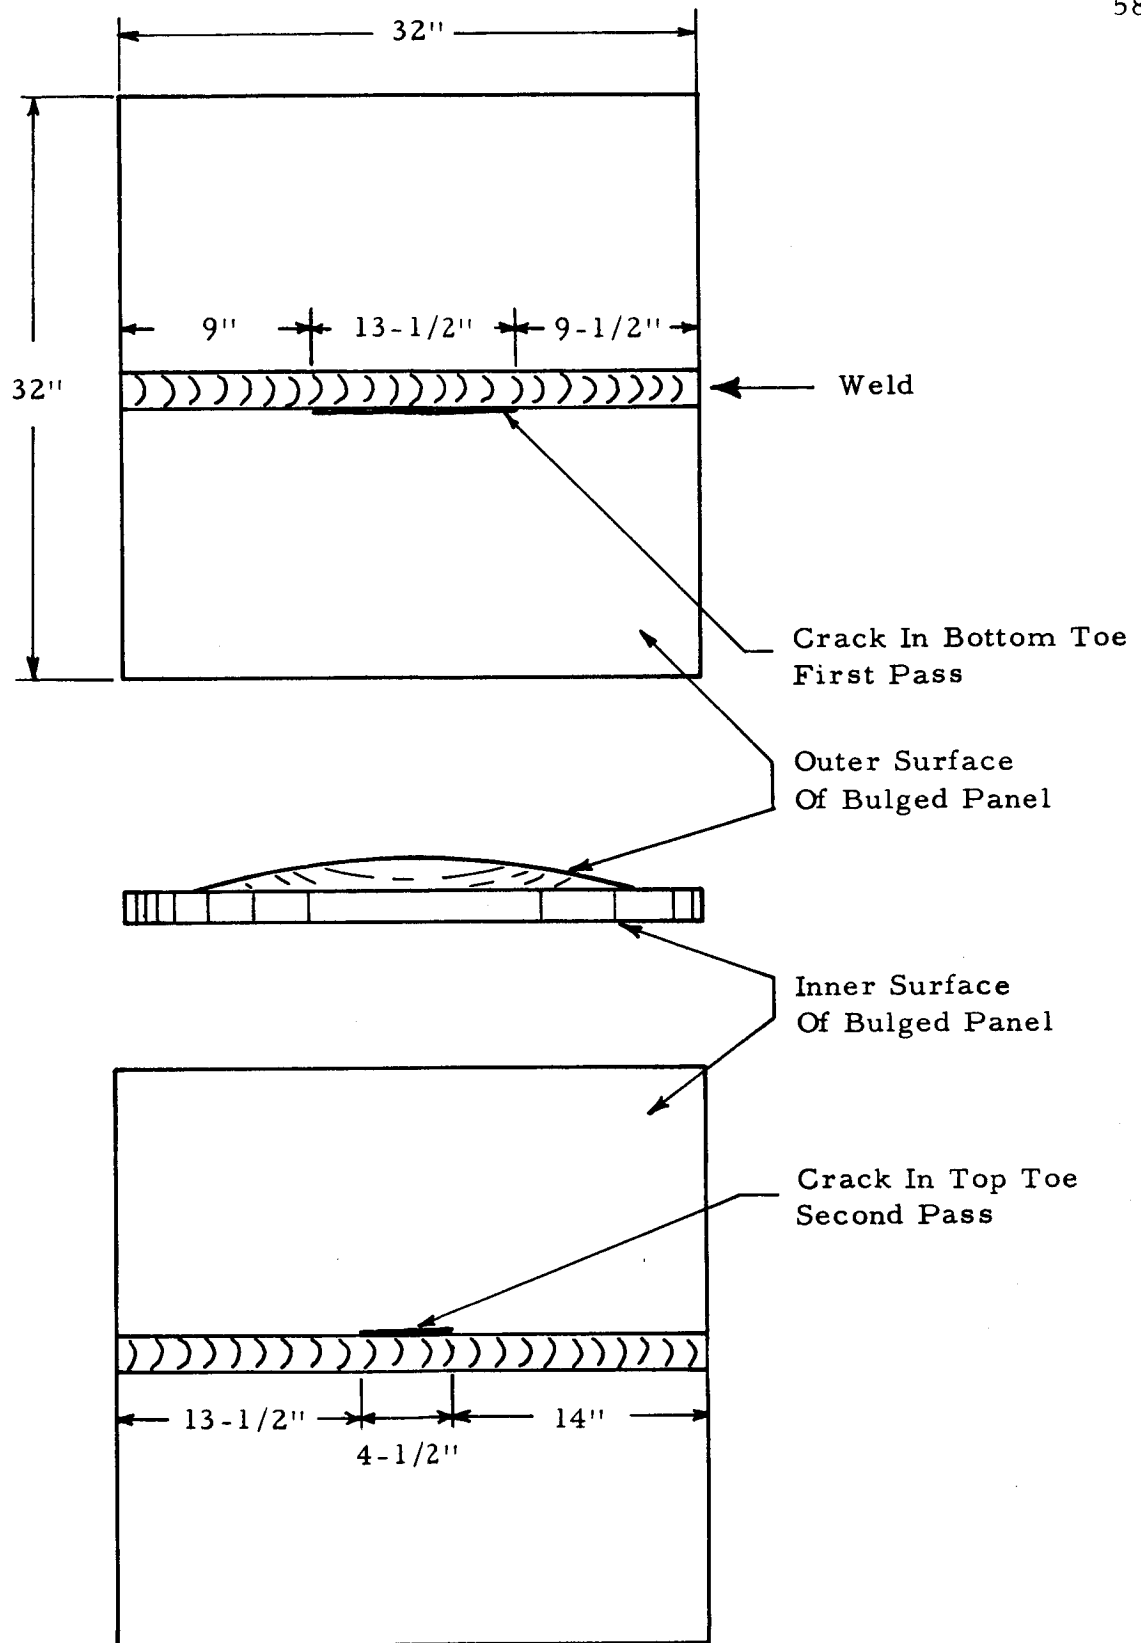
FIGURE 33. LOCATION AND MEASUREMENTS OF SURFACE CRACKS IN PANEL A

The surface measurements of the fracture which developed on this testing panel are shown in Figure 33. The outer surface of the bulged panel had a surface crack along 42 percent of its length. This was located in the bottom toe of the first weld pass. The crack on the inner surface was visible 14 percent of its length and was in the top toe of the

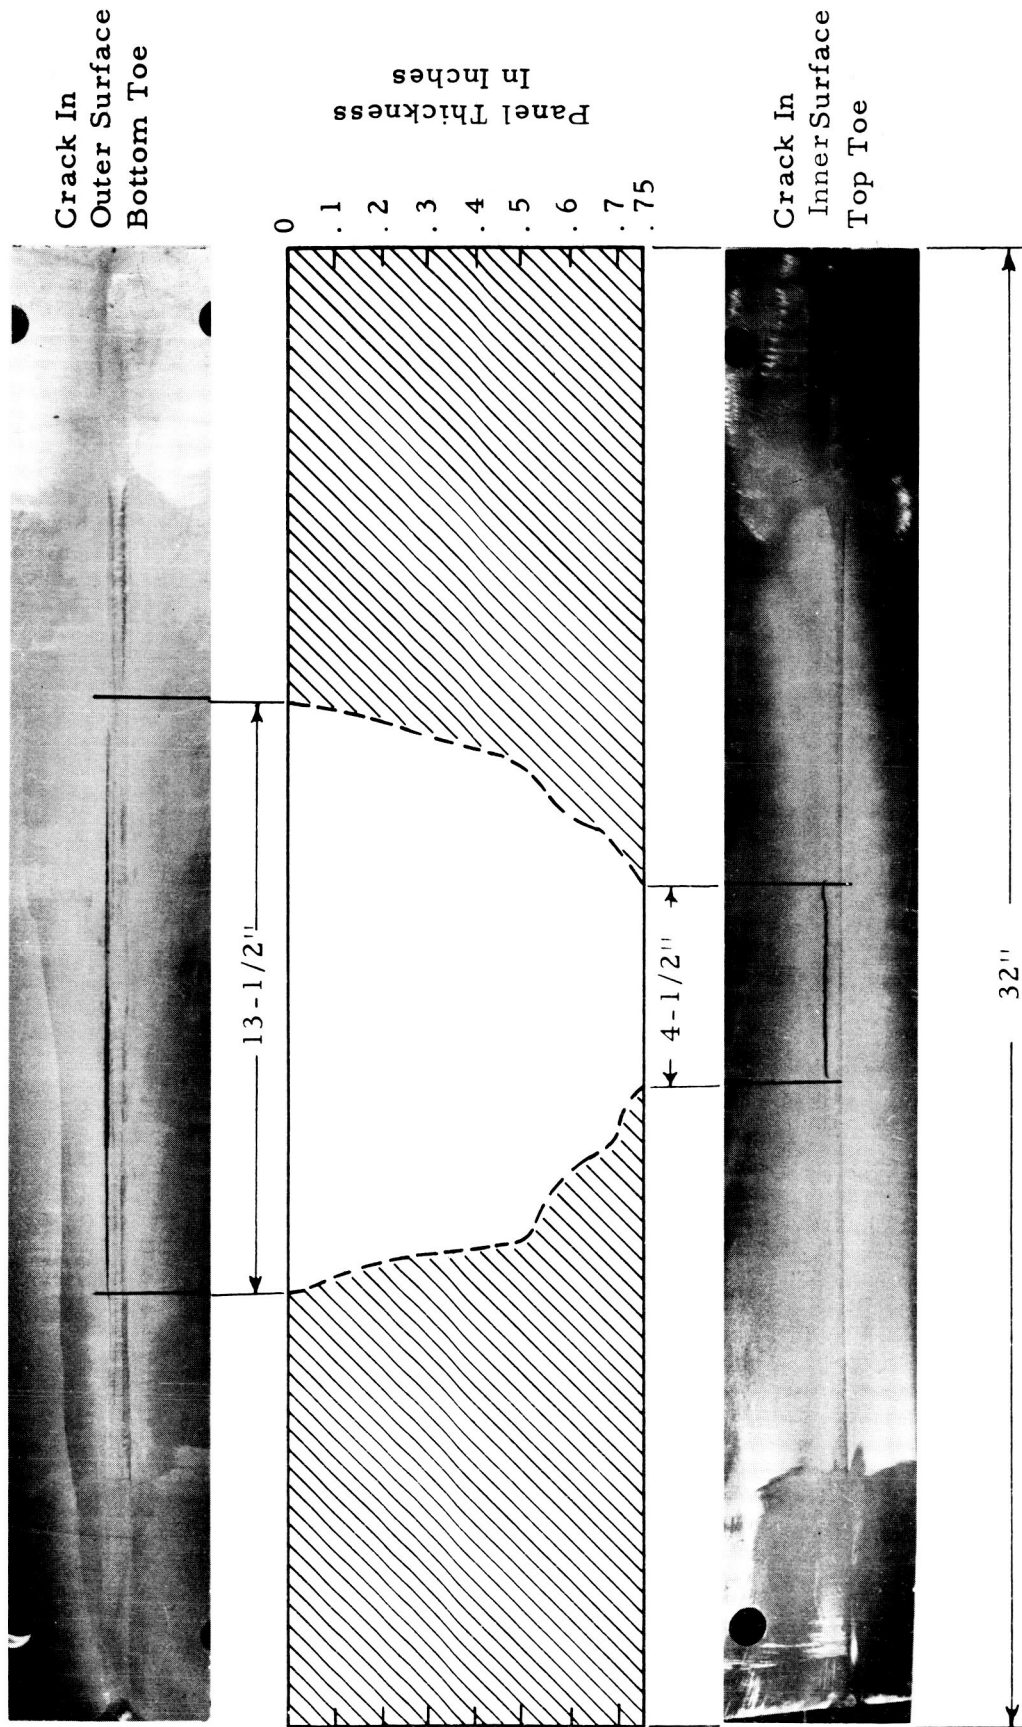
FIGURE 34. PROFILE AND LENGTH OF FRACTURE ON BOTH SURFACES IN PANEL A

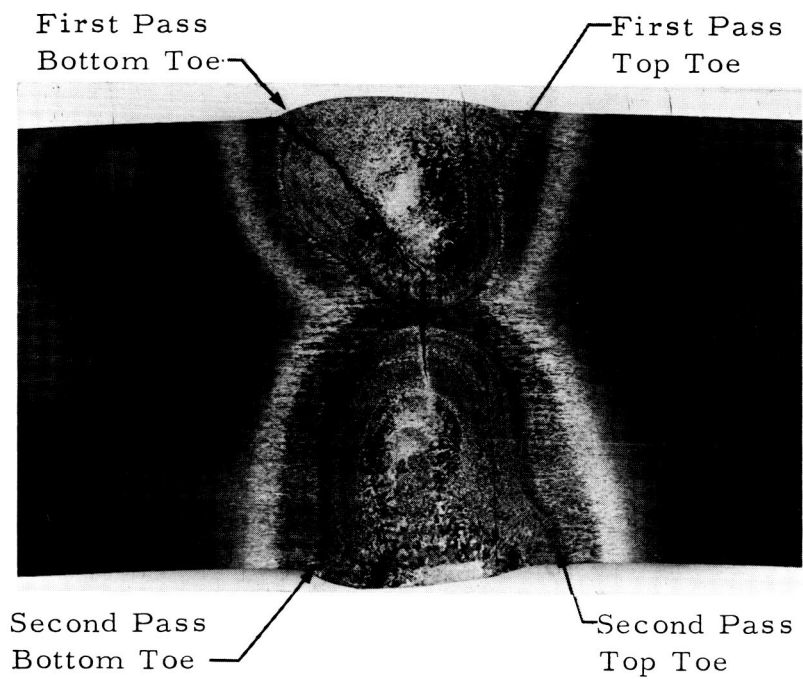
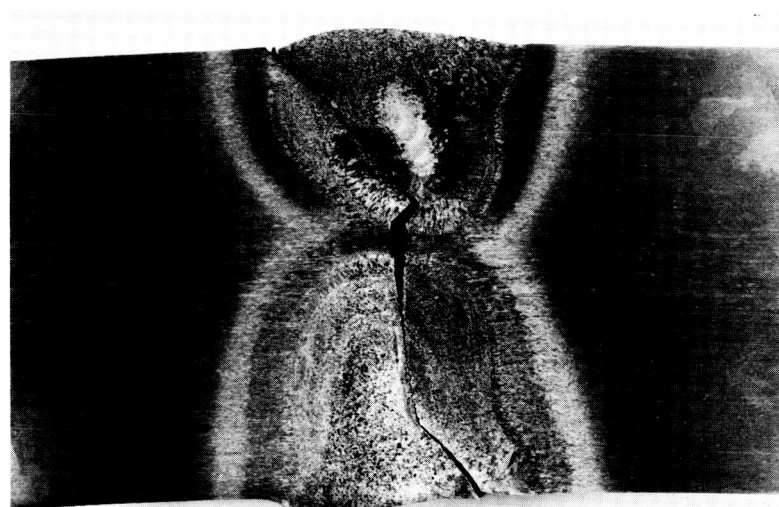
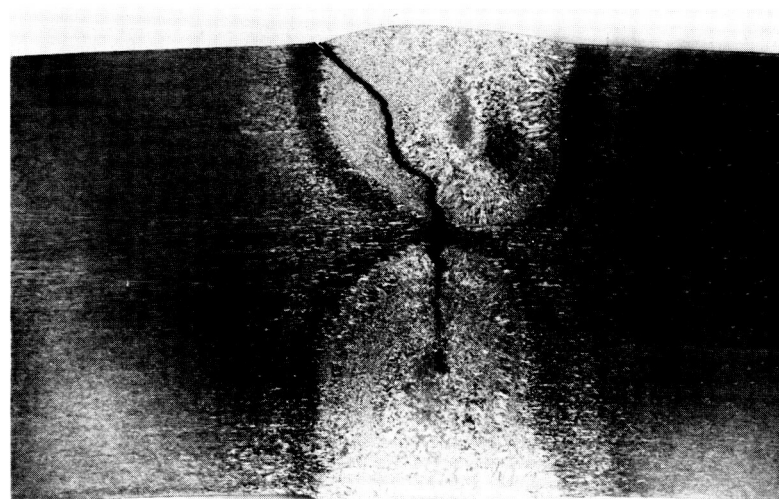
FIGURE 35. CROSS SECTIONS THROUGH CENTER AND ENDS OF FRACTURE IN PANEL A. Single butt weld with lack of penetration.

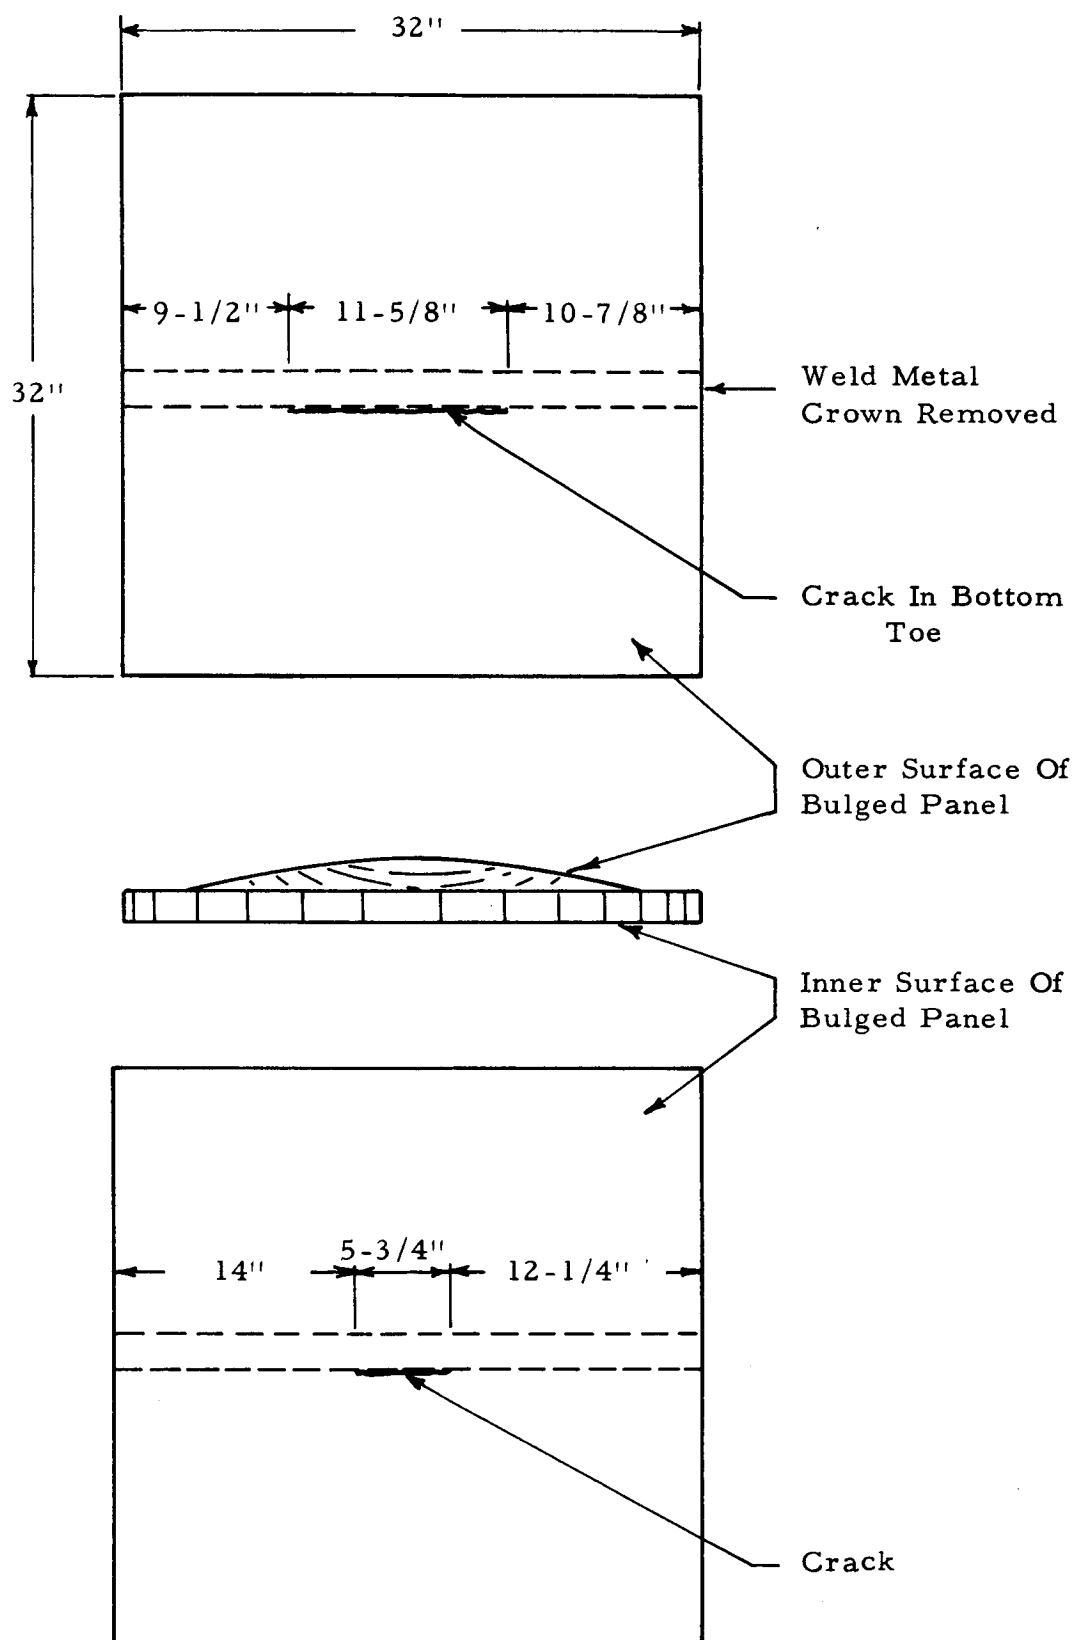
FIGURE 36. LOCATION AND MEASUREMENTS OF SURFACE CRACKS IN PANEL B. Weld crowns ground flush with base metal.

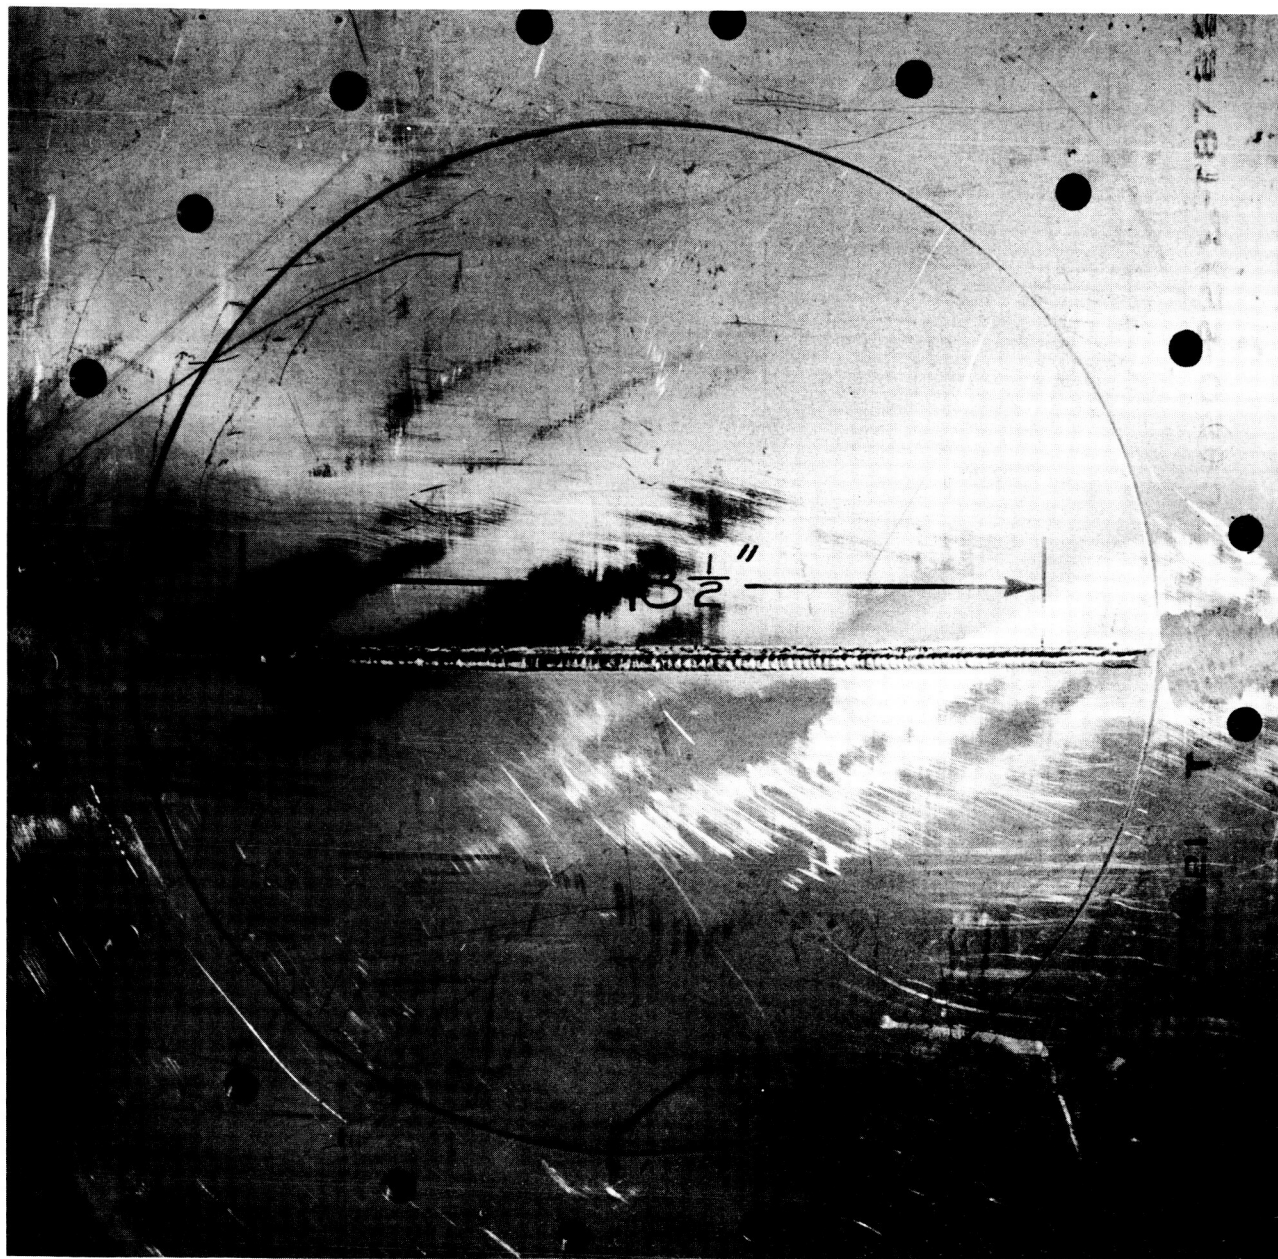
FIGURE 39. SURFACE CRACK IN PANEL C AFTER BULGE TEST

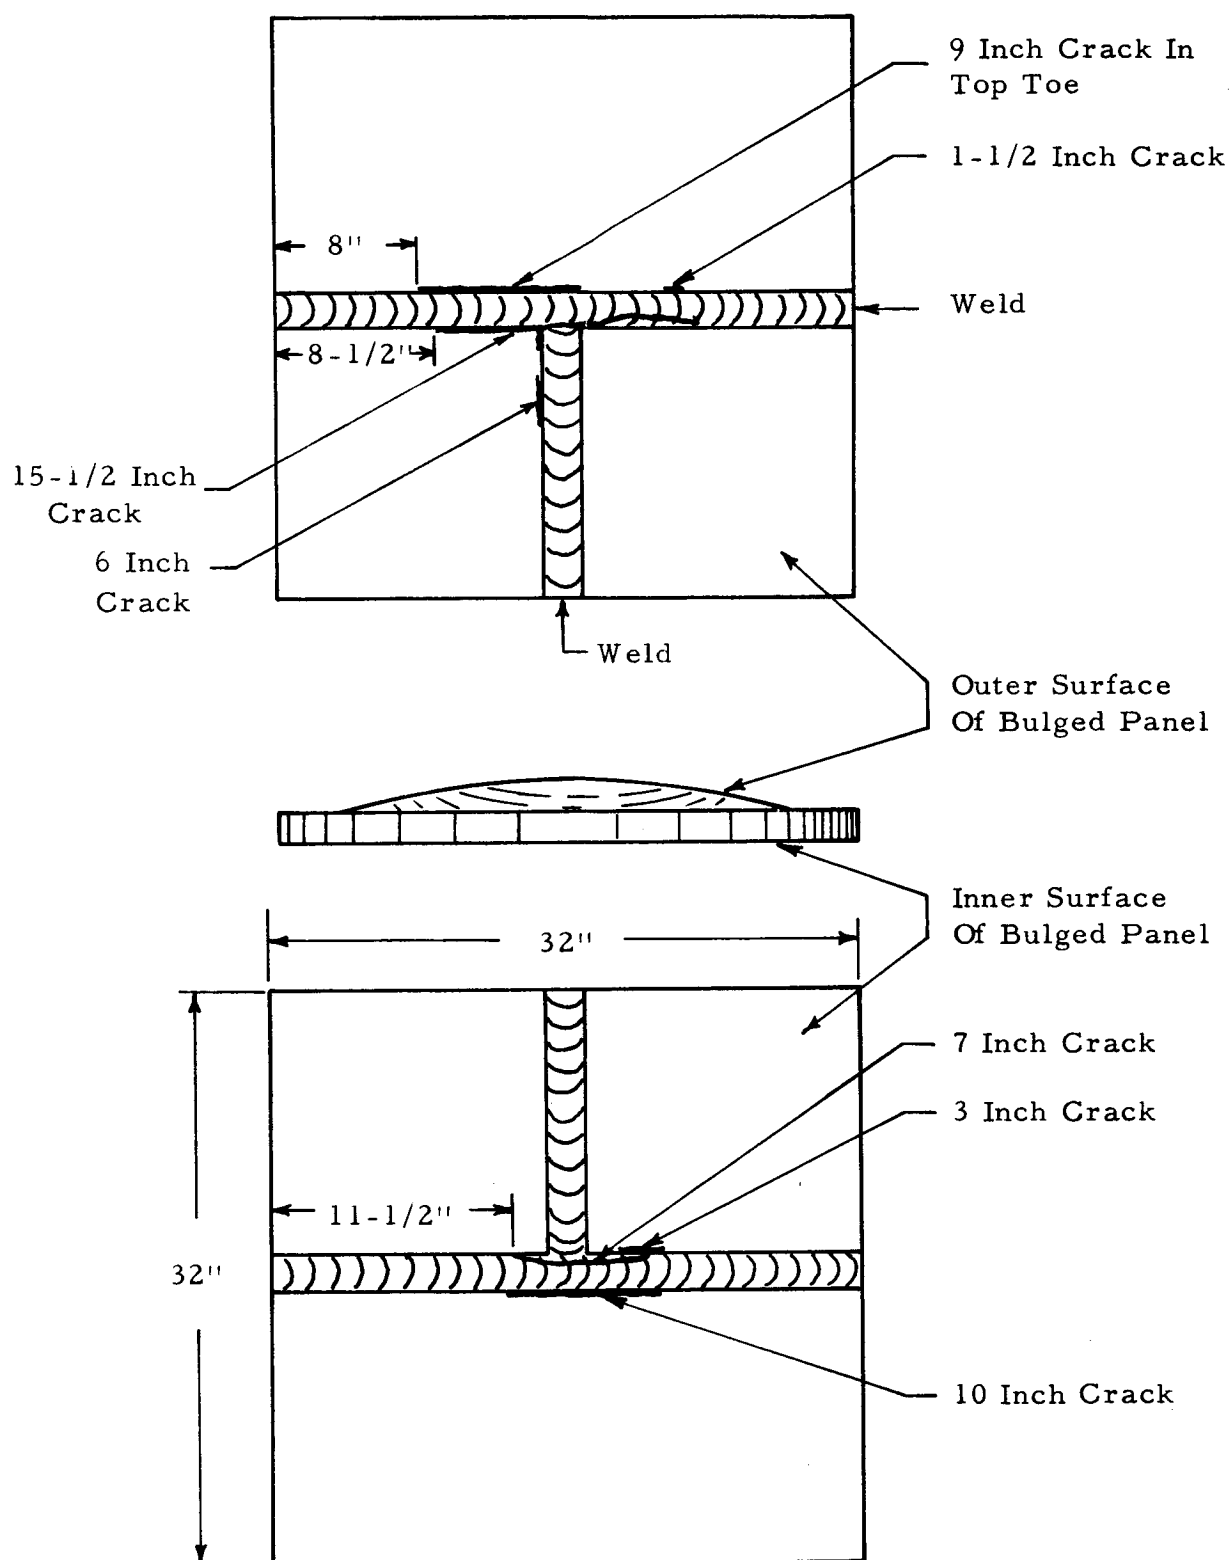
FIGURE 40. LOCATION AND MEASUREMENTS OF SURFACE CRACKS IN PANEL D

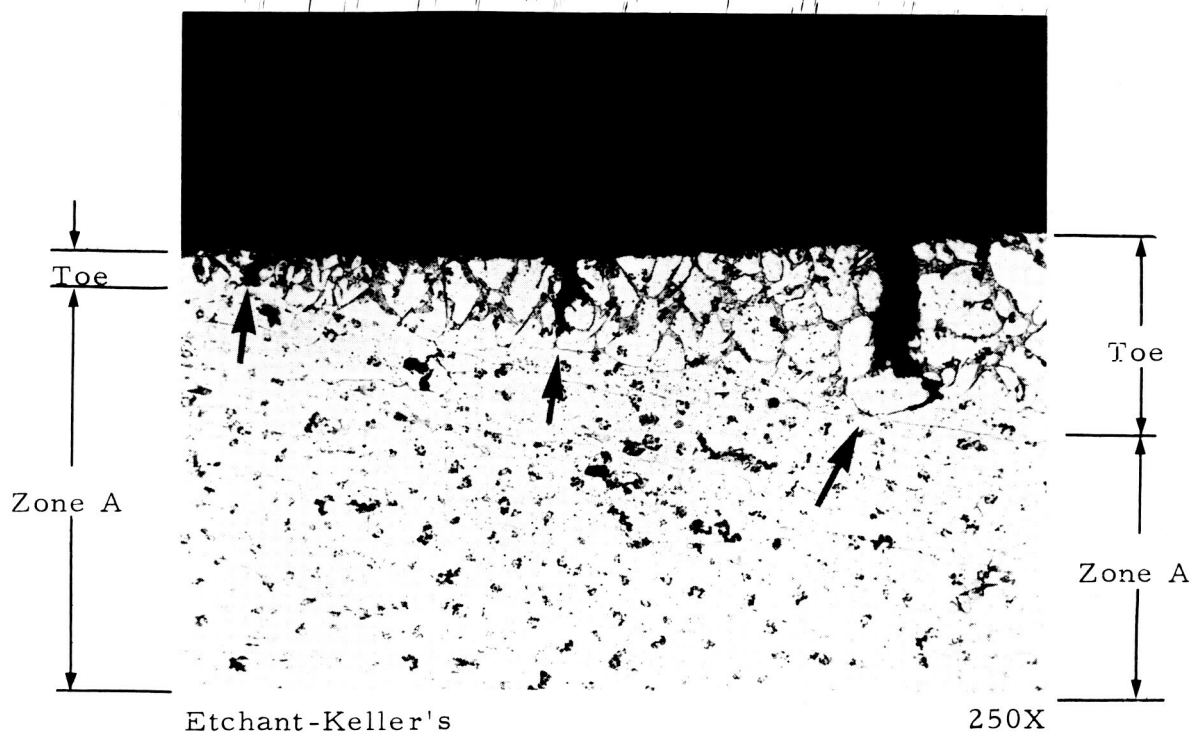
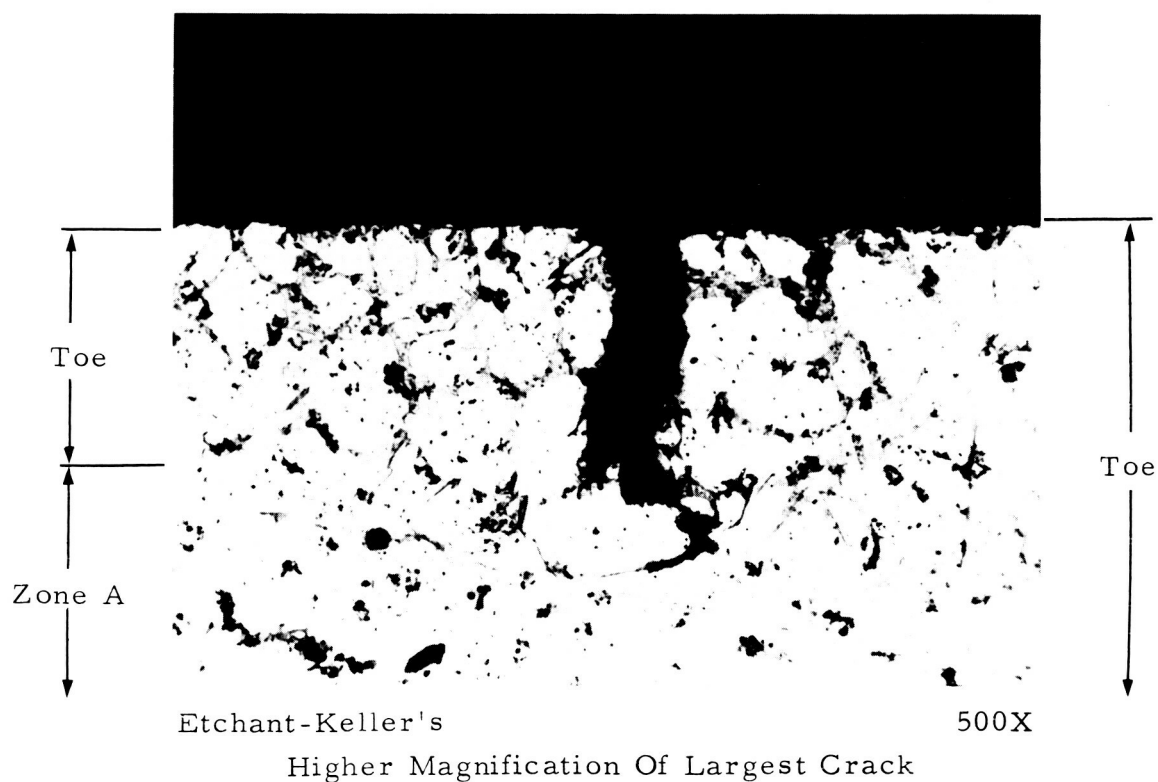
FIGURE 41. FORMATION OF CRACKS IN THE INTERMETALLIC CONSTITUENTS IN THE BOTTOM TOE OF A WELD PANEL AFTER BIAxIAL TEST

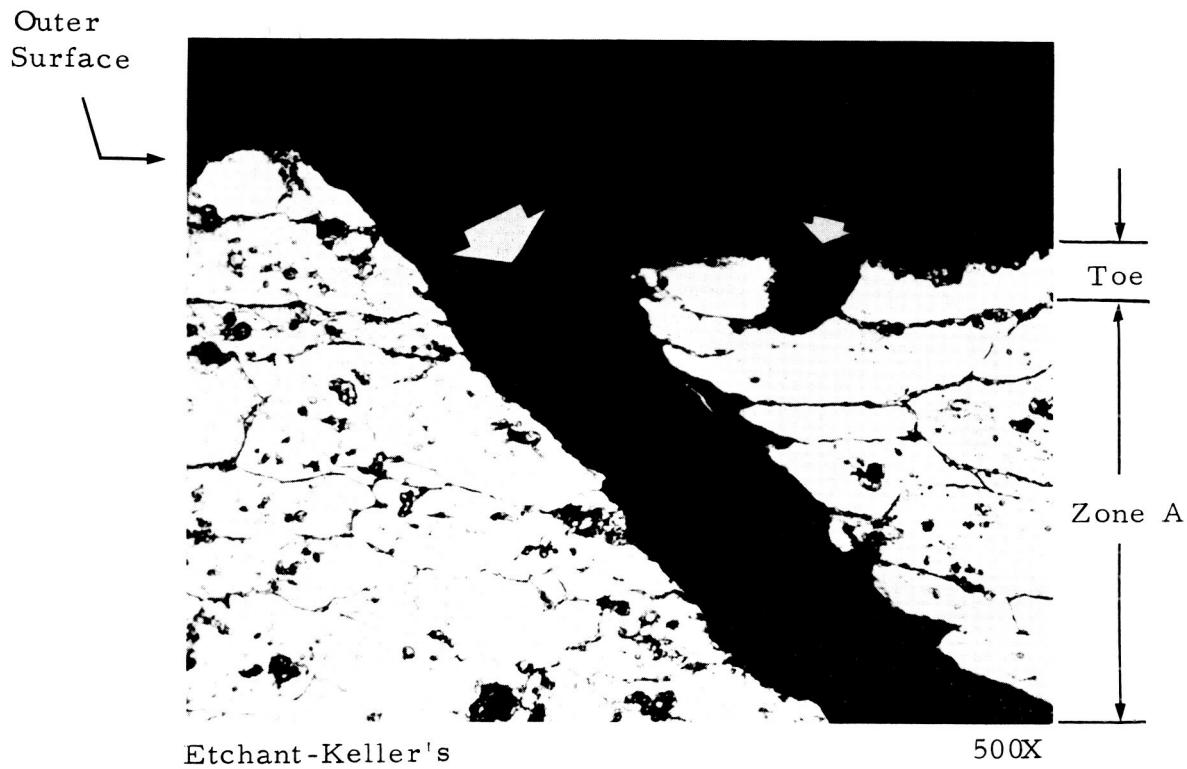
FIGURE 42. CROSS SECTION OF FRACTURE AT OUTER SURFACE OF WELD PANEL. Cracks initiating in weld toe indicated by arrows.

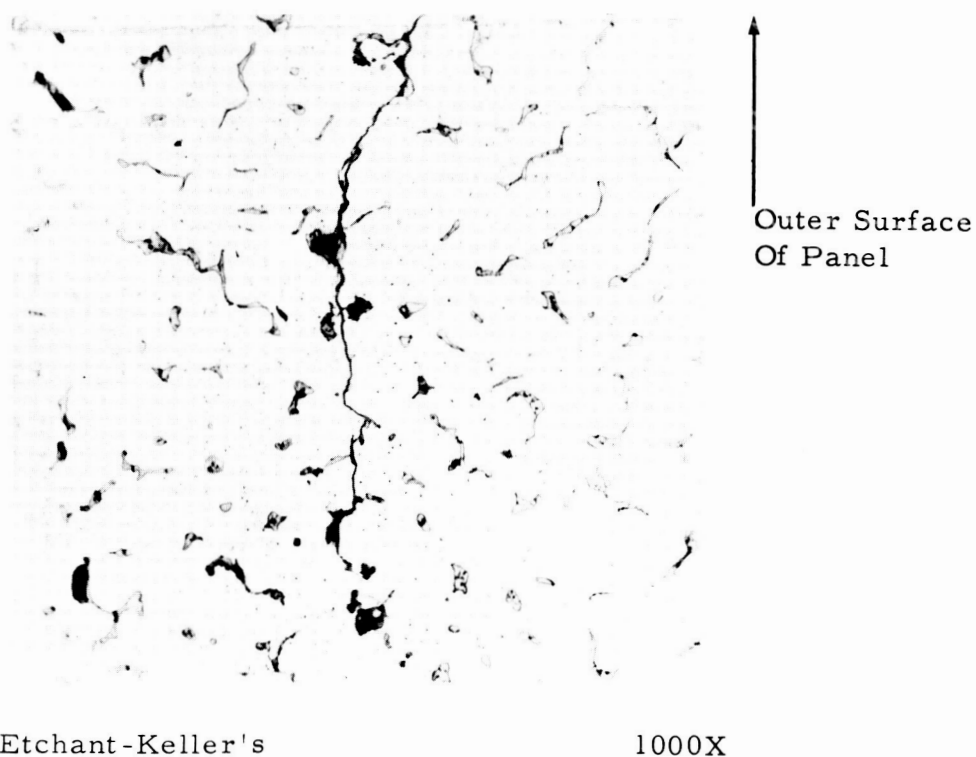
FIGURE 43. PATH OF FRACTURE IN WELD METAL
RESULTING FROM BIAXIAL STRESSING

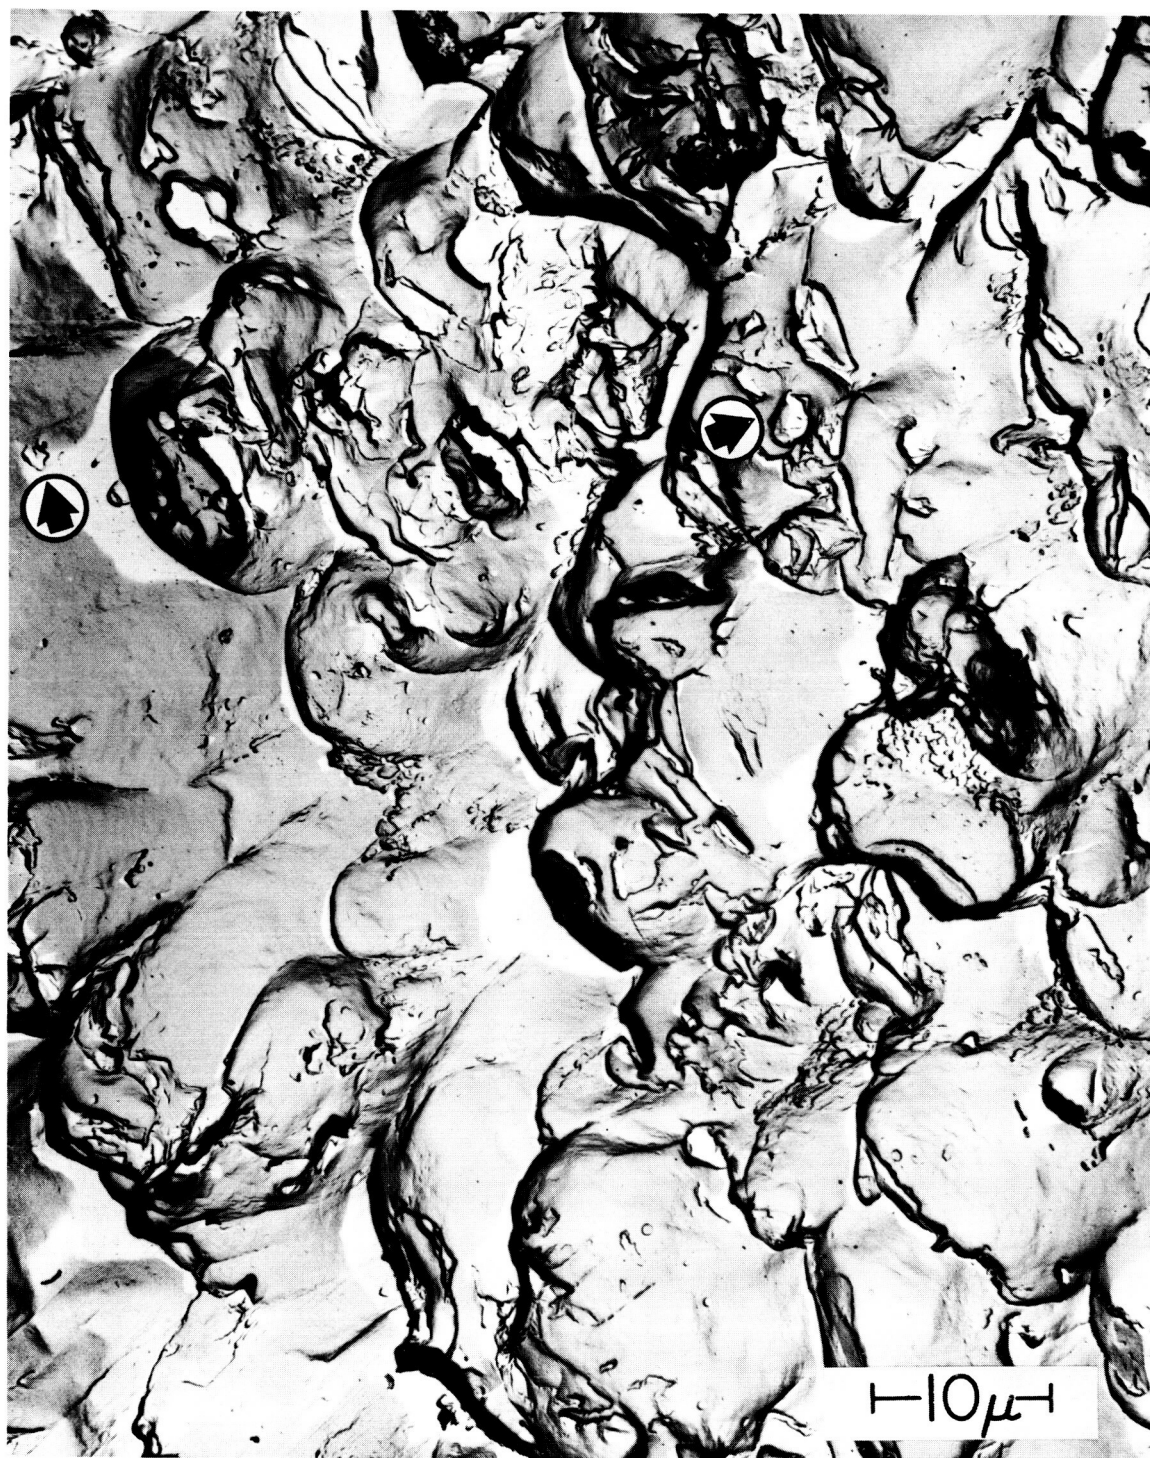
FIGURE 45. FRACTURE SURFACE OF 2219-T87 WELDMENT BULGE TEST PANEL. Specimen tested with weld crowns intact. Fractograph taken from location within first weld pass in Panel A (Area 1, Figure 44). Note the irregular shape of dimples. Arrows indicate dispersed second-phase particles in fracture surface.

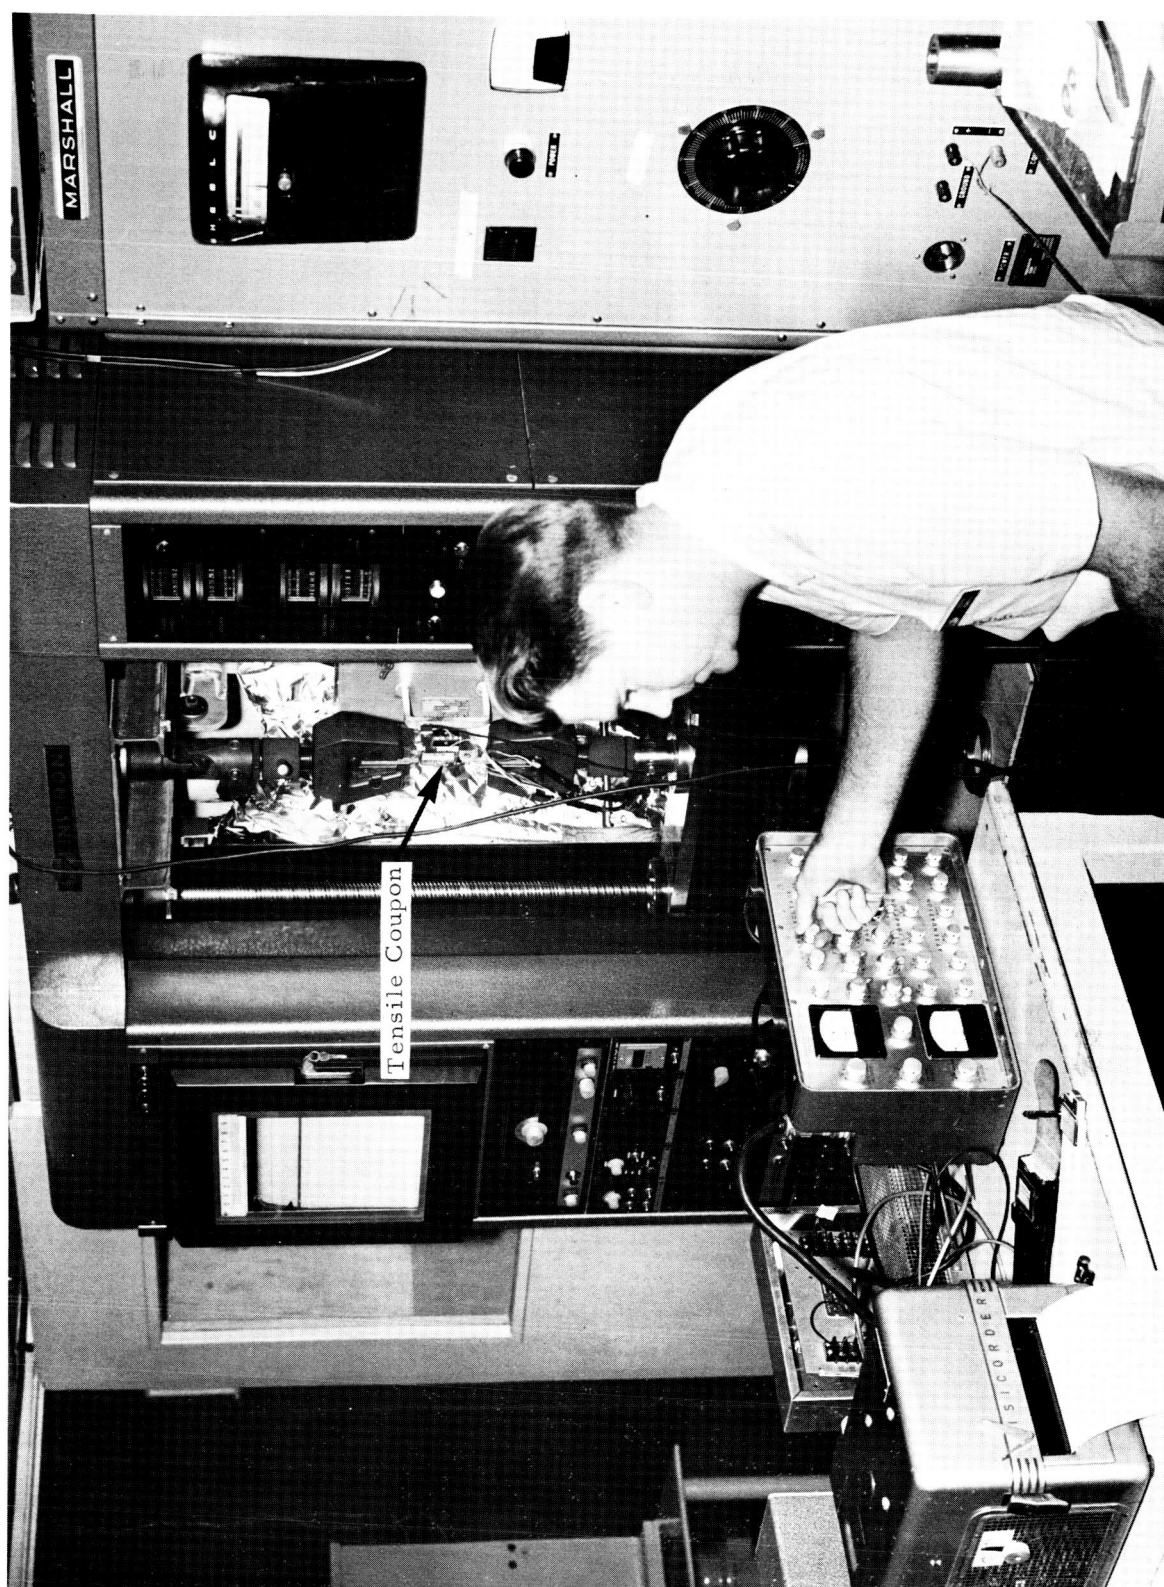
FIGURE 48. TESTING AND RECORDING EQUIPMENT. Arrow indicates tensile coupon.

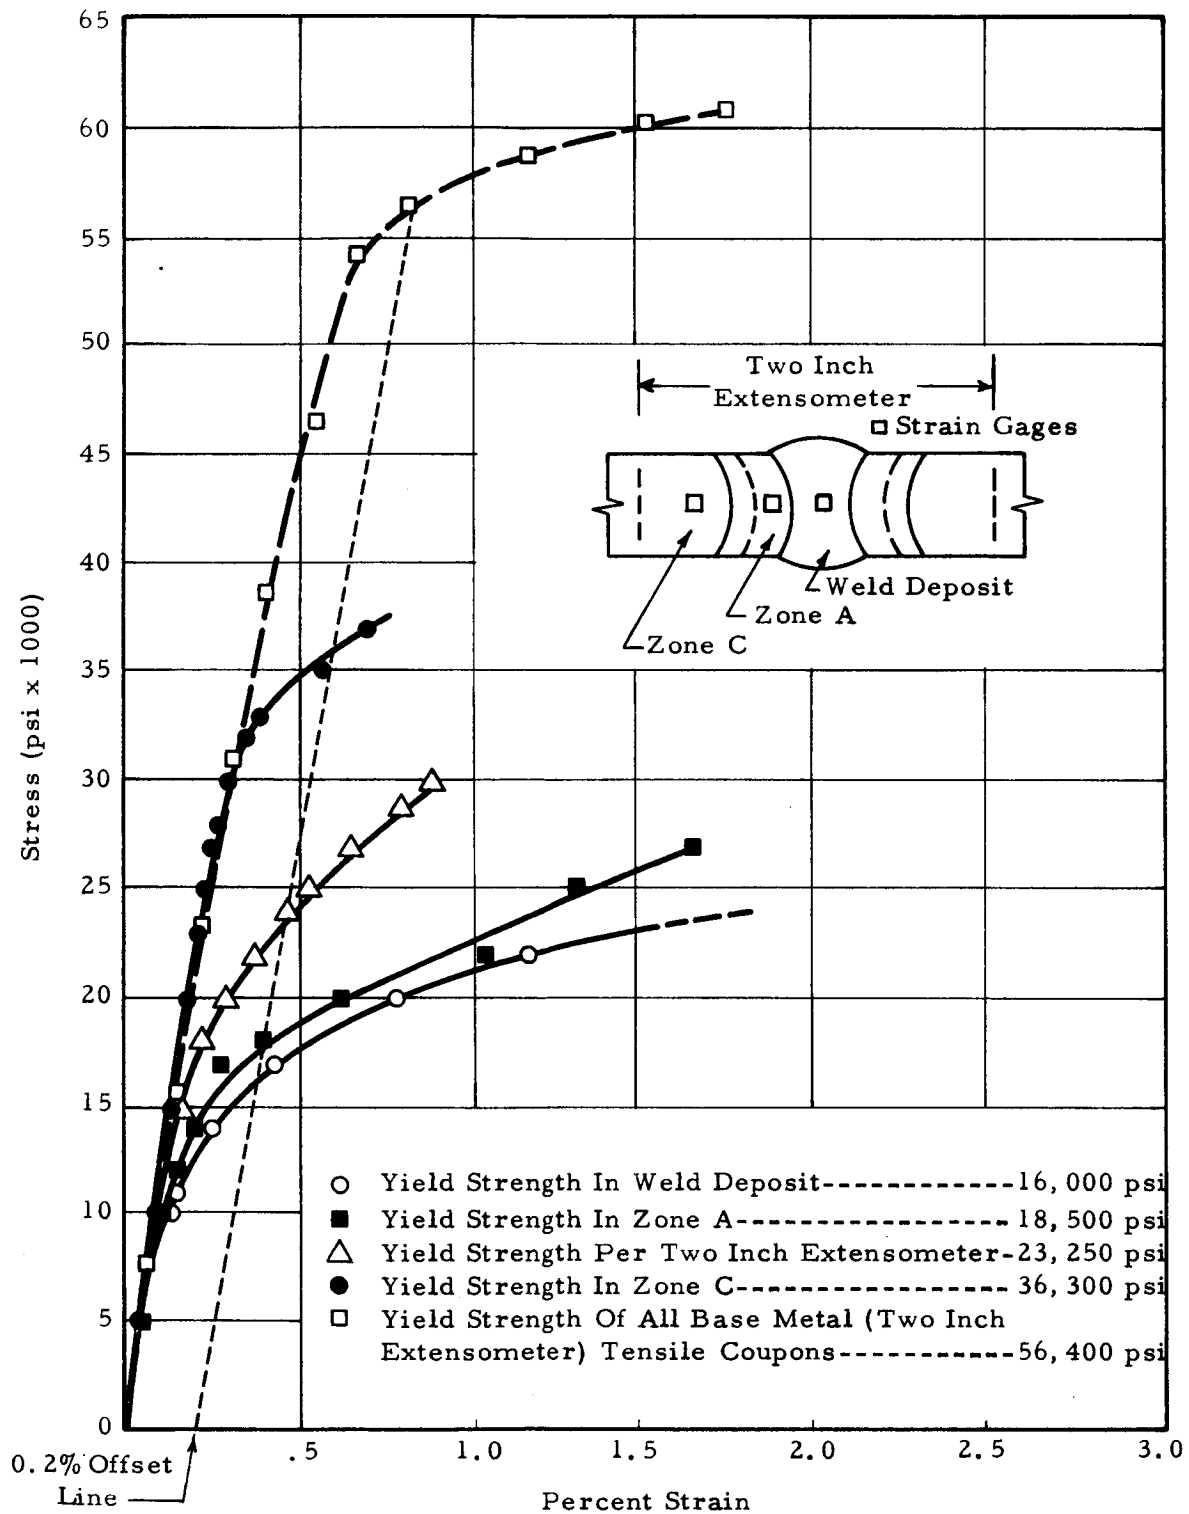
FIGURE 49. STRESS-STRAIN CURVES OF WELD DEPOSIT, ZONE A, ZONE C, AND PER TWO INCH EXTENSOMETER OF TENSILE COUPON. Note all base metal (two inch extensometer) curve from different tensile coupon.

Figure 52 was prepared from data plotted on Figure 49. The latter illustrates that when a standard ASTM two-inch gage length is employed to test weldments the yield strength of the weld deposit is likely to be exceeded long before the specified overall 0.2 percent offset is reached. It is also evident that the use of the "overall" yield strength for design purposes would be extremely hazardous. A more realistic testing method is desirable. The use of short gage lengths in a weld deposit and other limiting zones would be good in theory but rather impracticable in practice. It is felt
